Xerox® WorkCentre 4150 style... Getting the most out of the Drum Cartridges... Repair & Reconditioning WC- 4150, 4250, 4260

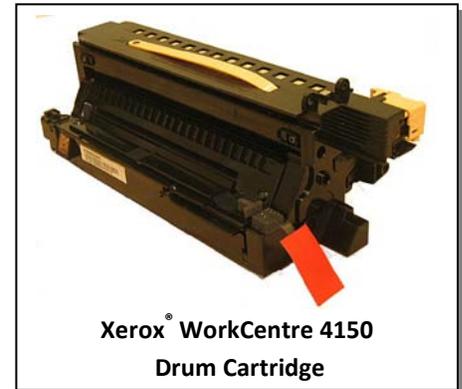
Like many of the newer consumables in the Xerox product lines, these cartridges use an RF (Radio Frequency) chip as a reset CRUM (Customer Replaceable Unit Monitor). The CRUM is found on the left lower side of the cartridge close to the rear. There is an RF communication board on the machine which the CRUM lines up with. This board can both read and write to the CRUM. Once the counter is up, the CRUM needs to be replaced to continue using the Drum Cartridge. The OEM CRUM is just a sticker with some tiny electronics in the middle. The generic replacements (which at the time of this article's creation are just being tested out), are hard chips with some peel and stick backing on them.

These cartridges include two basic halves... the top portion houses the Drum, Charge Roll, Cleaning Blade & Waste Toner Auger. The lower half is the Developer Housing. This cartridge is dual-component meaning it uses Developer Material on a magnetic roller. The Drum

Resetting the Drum count to extend the usable life of the cartridge will require only that you replace the Drum Reset CRUM on the left side of the cartridge. Eventually I am confident that the Drums and Blades and Charge Rollers will hit the aftermarket as well, at which point a more thorough rebuild will be possible.

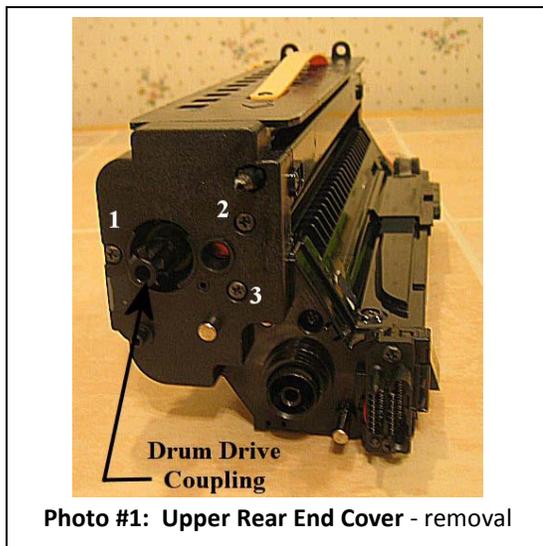
1. Start by removing the Top Rear End Cover (see Photo #1). You'll take 3 screws out (from the rear) and then you'll need to do a little wiggling from side to side to work the cover off of there.

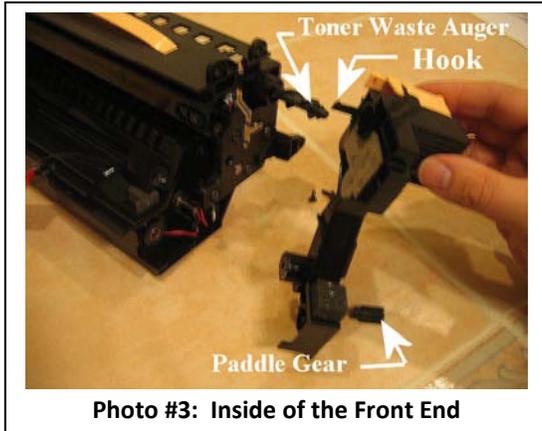
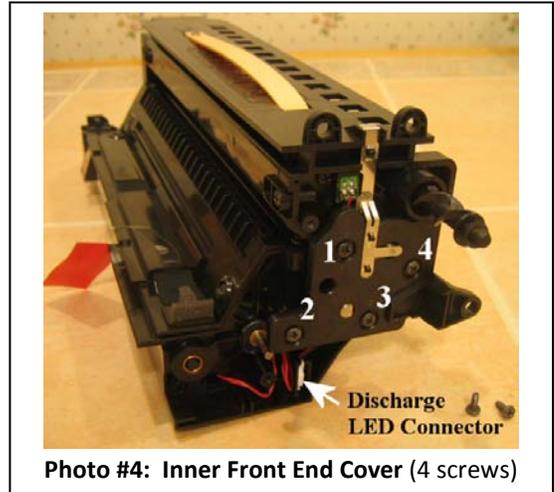
you'll release a single hook at the top right where it sticks through to just above the drum. There is a small paddle gear which pulls off of its 'D' shaft when you remove the Outer Front End Cover and it will then fall right off. (see Photo #2)

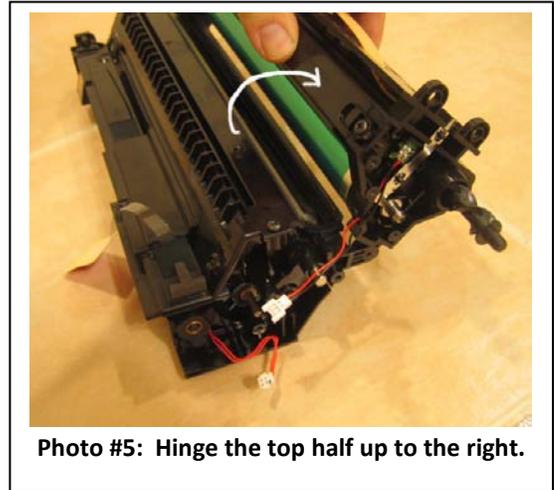
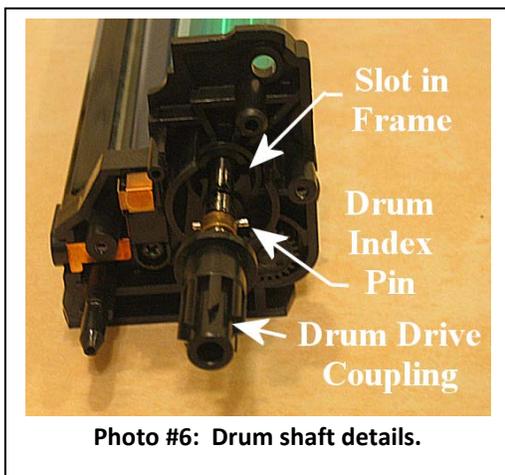
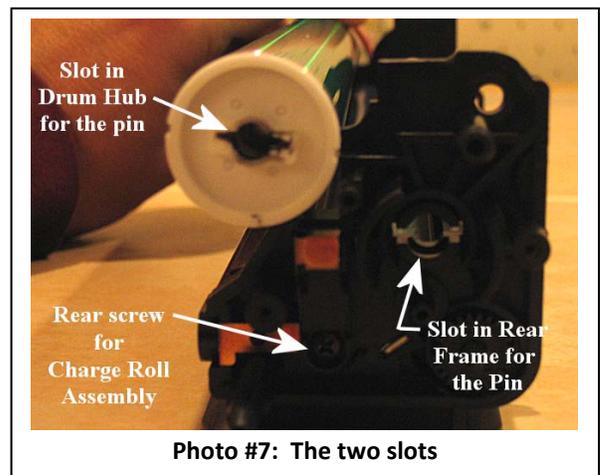
- Then remove the Inner Front End Plate (see Photos #3 & #4). 4 screws from the front end.
- Now for the “big moment”... you will separate the Upper (drum) half and the Lower (developer) half. Start by disconnecting the

white connector for the Discharge LED which is tucked into an alcove low down on the

front end. Then the entire top half of the cartridge can hinge up to the right (see Photo #5)... Now shimmy it backwards off its hinge pins and lift it on off of there.

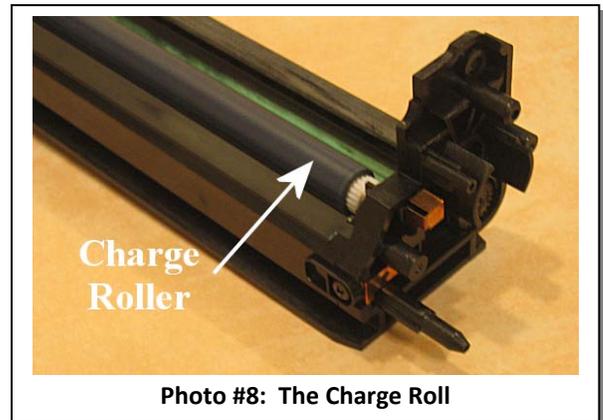
Photo #8: The Charge Roll

- Next you can remove the Charge Roll Assembly (2 screws from the right side, 1 screw from the front end and 1 screw from the rear end). See Photo #8. Clean out the Charge Roll Assembly carefully and vacuum the sponge cleaning roll in the assembly.

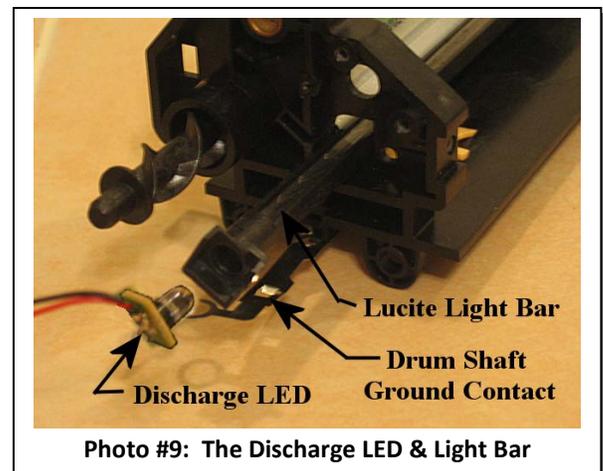
Photo #9: The Discharge LED & Light Bar

- To get to the Blade you must first remove the Discharge LED & its Light Bar (it looks like a long discharge lamp but at closer inspection, you'll see it is really just a single LED at the front end which lights up the lucite Light Bar (see Photo #9) the Light Bar is somewhat flexible in spite of its fragile appearance) You'll want to start by removing the front Drum Shaft Ground Contact (pry very gently at the metal where it is pushed onto each of the 2 plastic posts... don't mangle it... you want to be able to push the metal burrs back onto the posts later and have them still be able to grab the posts firmly). With the contact out of your way, you can push the Discharge Light Bar forward and out through the front end. You can remove the Discharge LED Board with ease to clean the LED.

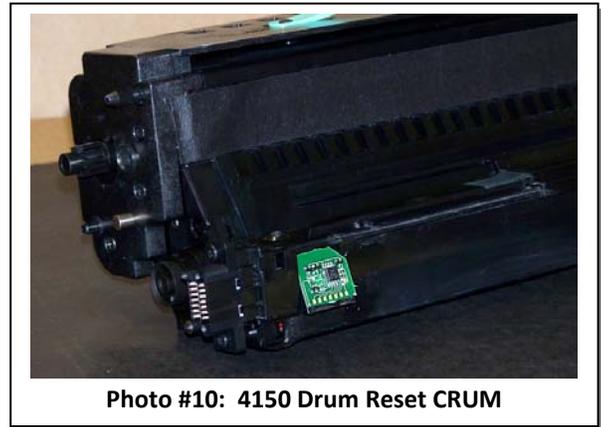
Photo #10: 4150 Drum Reset CRUM

8. Finally now that the Discharge Light Bar is out of the way, the Drum Cleaning Blade can be removed (2 screws).
9. Reassemble everything, and replace the Drum Reset CRUM. On the 4150 it is located on the lower left side of the cartridge (do not install the new CRUM over the old one.. make sure to remove the old one first or it will confuse the communications with the machine). Make sure the new CRUM is as “flush” as it can be. (See Photo #10). On the 4250/4260 cartridges it is located inside the Front End Cover (See Photo #11)
