## Xerox 7132 style Drum Cartridges...

### 13R622 - Cartridge Reconditioning Information for Xerox WorkCentre 7132, 7232 & 7242

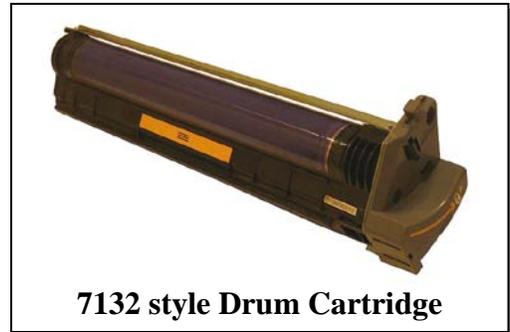
The Xerox WC 7132 series are full color copiers / multifunction machines based on the frame of the black & white C123 series. Aside from the outer shape, and a few of the parts (document feeder and paper feed units for example), the similarities are few and far between. Today we'll take apart a drum cartridge, which is proving to be one of the more profitable items to work on. While these cartridges are fairly straight-forward to disassemble, there are a few places you'll probably appreciate a heads-up before you proceed... mostly it's about stuff which will fall out uninvited and get lost if you're not paying close enough attention.

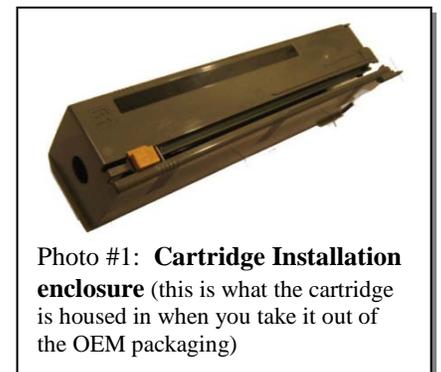
When the customer pulls the cartridge out of its carton, it is housed in an installation enclosure (see the Photo #1)

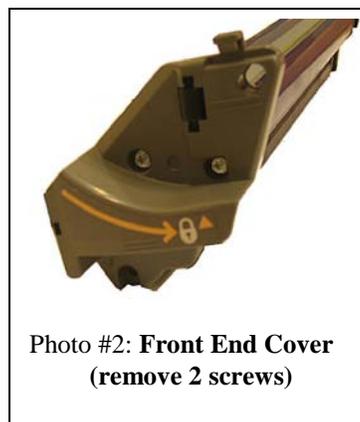
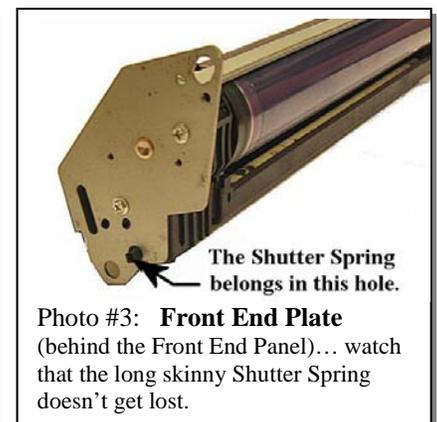
- 1.) **Remove the gray Front End Cover** (2 screws) (see Photo #2). Watch for, and retrieve a long skinny spring (the Shutter Spring) which is tucked into a black hole. It could easily fall out and could get lost. (see photo #3). Be very gentle, the little spine of plastic which serves as the Cartridge Home Actuator is on this Front End Cover and if it gets broken, the machine will complain that the cartridge is not installed or not seated. (see photos 11 & 12)

- 6.) **Next hold onto the Drum while removing the Front Metal Plate.** Take care... the plate has the front Drum Spindle built into it... Once the plate is removed, the drum will fall right off. Also now you will want to remove the auger shutter (a small plastic sliding plate which covers the auger's hole... it can fall right off once the Front Metal Plate is removed). Refer back to Photo #3.

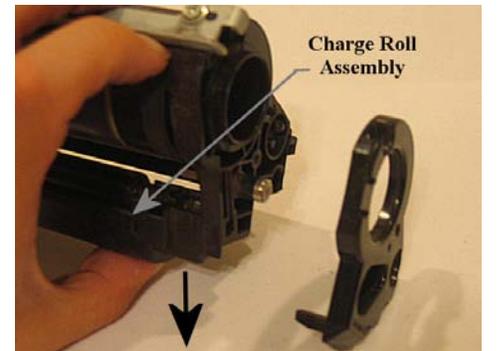
Photo #4: **Rear End Cover removal...**  
The Charge Roll Assembly will drop down once the Rear End Plate is extracted.

- 2.) **Remove the Top Metal Rail** (2 screws, one at each end).
- 3.) **Next remove the Rear End Cover while holding onto the rear end of the Charge Roll Assembly** (see Photo #4). This is important because the Rear End Cover has a long protruding piece which retains the Charge Roll Assembly... when the Rear End Cover is removed, the Charge Roll Assembly will fall right off. If that is ever to happen to you, you'll want to refer to Photos 5, 6, & 7 which show the 3 pieces which form the rather complicated bearing and contact menagerie at the rear end of the Charge Roll assembly.

- 4.) **The Charge Roll Assembly drops down at the rear to then pull out of the Front End.** The unit is made up of

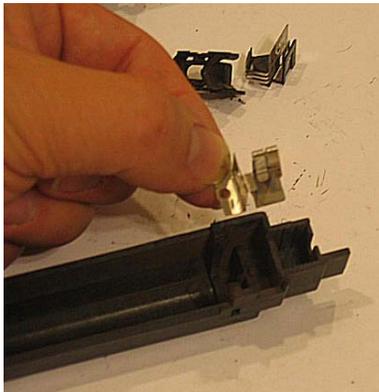
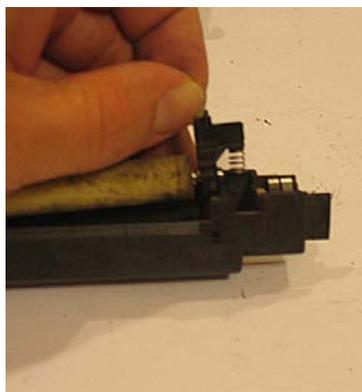
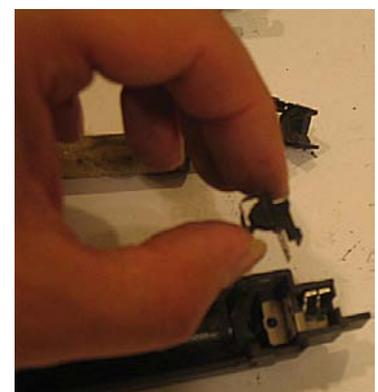
Photo #5, 6, & 7: **Charge Roller Assembly...** watch carefully how all this comes apart !

a Charge Roll set into line bearings with a Cleaning Roll beneath it in the same line bearings. Then there is a metal clip which serves as the grounding piece for the Charge Roll Assembly. Finally there is yet another piece which serves as the Charge Roll's actual Contact Terminal. See Photos 5, 6, & 7 to help reassemble stuff after you are done cleaning everything. The Charge Roll itself will respond well to sink washing with warm water and soap. Rinse it good and let it dry completely.

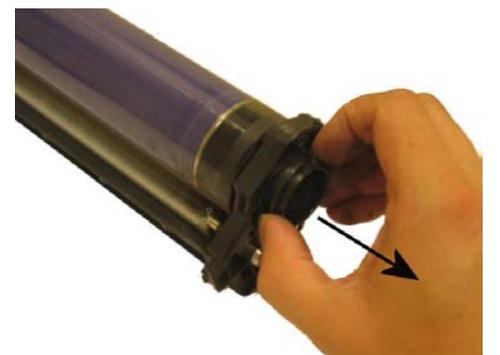
Photo #8: **Rear Drum Bushing removal.**

- 5.) **Now remove the Rear Drum Bushing**... it extracts straight out with little effort (see Photo # 8)

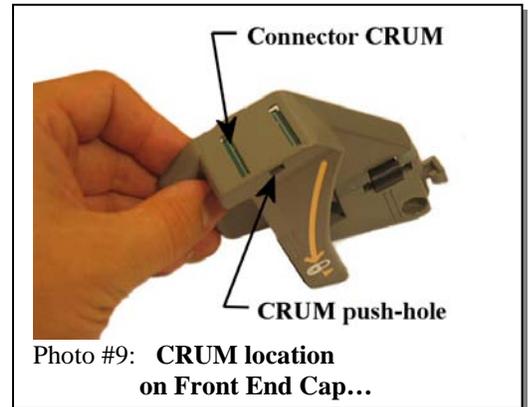
Photo #9: **CRUM location on Front End Cap...**

- 8.) **Finally replace the Drum Reset Connector CRUM (chip) in the Front end Cover** (see Photo #9). You will need to flex the CRUM and the cover a little bit to get the CRUM to slide out past the plastic retaining burr... then use a long narrow tool to help push the CRUM the rest of the way out (you can push through a square cut out on the plastic cover. The generic CRUMs we've seen so far all seem to have larger electronic components compared to their OEM counterparts... but they fit ok if you put the electronics stuff facing inward.

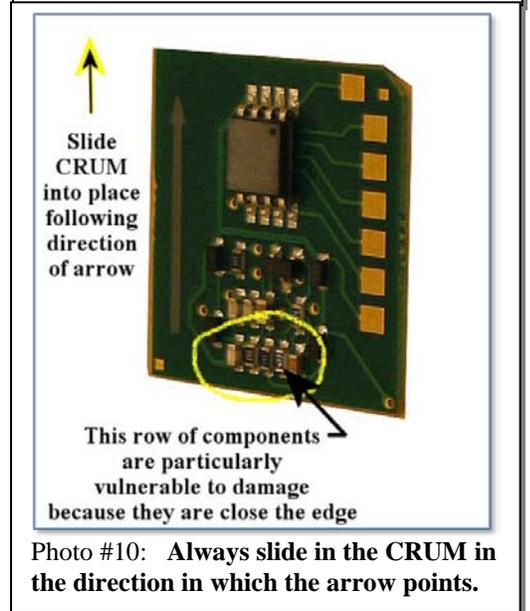
Photo #10: **Always slide in the CRUM in the direction in which the arrow points.**

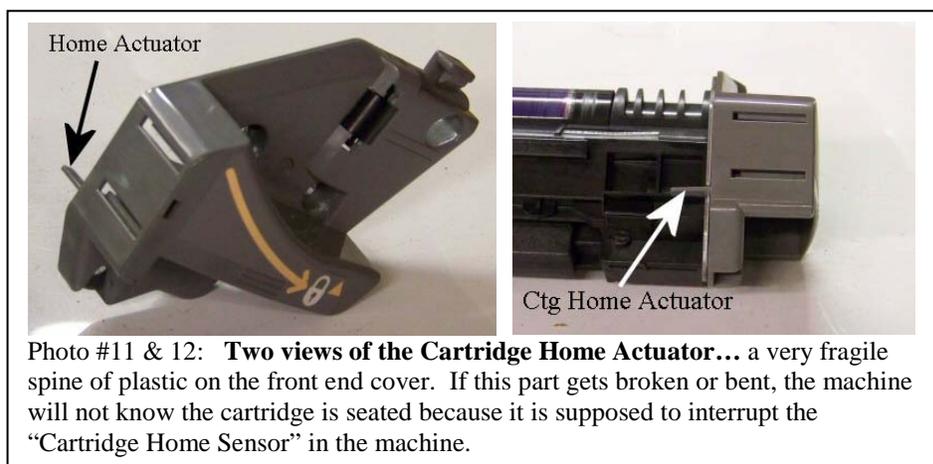
Photo #11 & 12: **Two views of the Cartridge Home Actuator...** a very fragile spine of plastic on the front end cover. If this part gets broken or bent, the machine will not know the cartridge is seated because it is supposed to interrupt the "Cartridge Home Sensor" in the machine.
