Fuser Repairs: Xerox C118, C123, & 5225 styles... Servicing the Fuser Modules for the Xerox CopyCentre C123, C128, C133, & WorkCentre M123, M128, M133, Pro123, Pro128, Pro133... also the C118, M118, M118i... and the Phaser 5500:

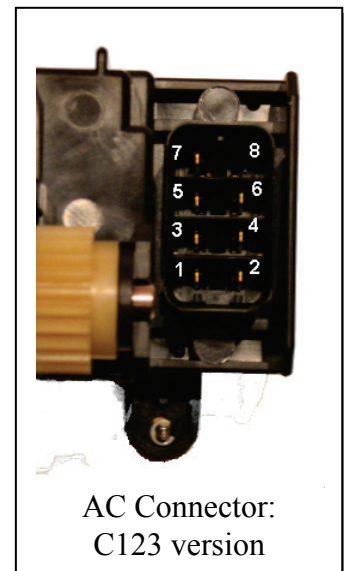
On the C123 & WC-5225 versions, there are slots for 8 pins (2 rows of 4 arranged vertically). Pin 7 is on the upper left and Pin 8 on the upper right is empty. Pins 7 & 1 are one of the two Heat Lamp Circuits. Each Heat Lamp Circuit goes through its respective half of the Heat Lamp Assembly, and then through both thermal fuses to the return wire (pin 7 is the return wire which is common to both heat lamp circuits). Pins 7 & 3 are the other Heat Lamp Circuit. If either Thermal Fuse is blown, neither lamp circuit will conduct. If one circuit measures good and the other measures bad, then the Heat Lamp Assembly must have failed.

The Thermistor circuits for the C123 are between Pins 2 & 4 and Pins 5 & 6. If you set your meter to 200K ohms, you can measure the Thermistors... they should measure a high resistance and then if you were to warm up the Thermistor’s head, the resistance should begin to drop. These Thermistors are unusual in that the heads are naked (no yellow kapton tape).

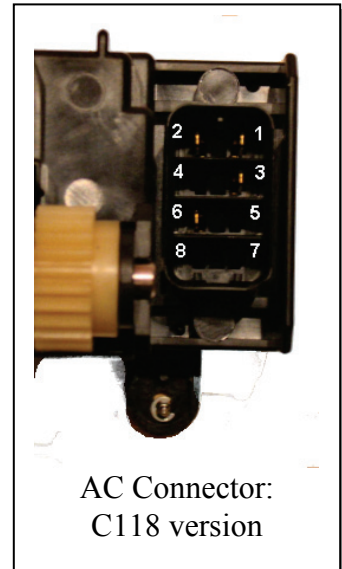
The C118 fuser's AC Connector is shaped the same as the C123 version (slots for 8 pins) however there are only 4 pins actually present and they numbered the pins differently for this one. On this one, Pin 2 is in the upper left corner and Pin 1 is in the upper right. On this connector, Pins 1 & 3 form the Heat Lamp Circuit. The Thermistor Circuit is between Pins 2 & 6.
