## Repairing the Xerox Fax Drum Cartridges... Pro635/645/657, Pro665/685/765/785

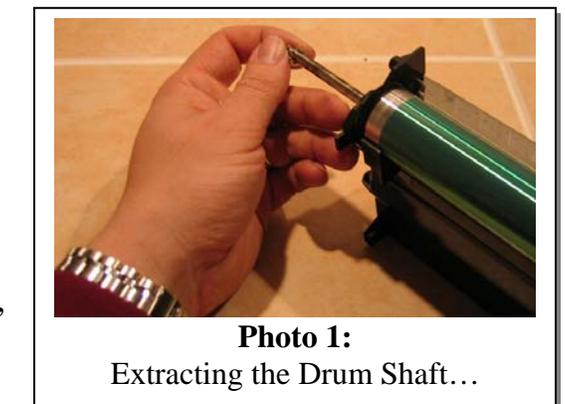
**Photo 1:**  
Extracting the Drum Shaft...

The first step in this procedure is to remove the rear E-clip from one end of the Drum Shaft and extract the shaft from the other end (see Photo 1). Then you can lift the Drum out of its cradle and put it aside where it'll be safe and protected from light.

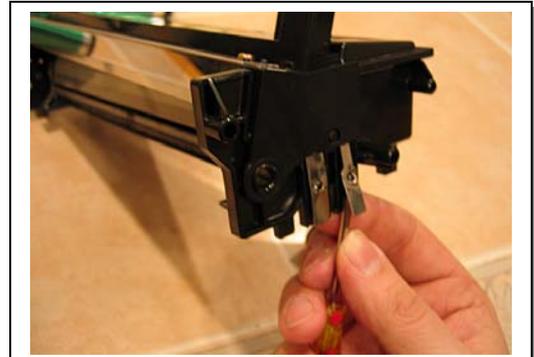
**Photo 3:**  
Releasing the Rear Charge Contacts

best done by first releasing the front end and lifting it slightly (see Photo 2), then go to the rear end and release the two Charge Contacts with a small flat head screwdriver (see Photo 3)... they are pressed onto a plastic post so you'll need to be very gentle with the contacts, so as not to deform them any more than is absolutely necessary. You can then lift the Charge Corona / Discharge Lamp Assembly off of the Cleaning Assembly portion of the cartridge exposing the Cleaning Blade.

Now you can reassemble everything. Start with reinstalling the Charge Corona / Discharge Lamp Assembly... pay careful attention to the two contacts ... they should be flush with the plastic once you "snap" them back in place (if they're protruding, they may get hung up when your customer goes to drop the cartridge back into the machine). Be careful when sliding the drum shaft in through the drum as there's a grounding clip inside the drum which you don't want to mangle.

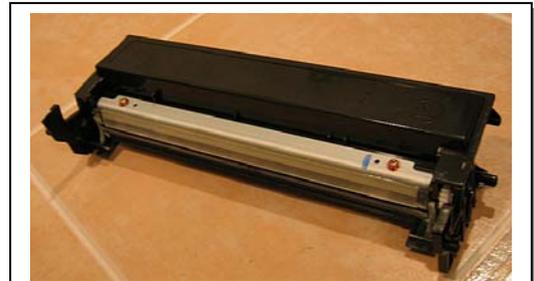
**Photo 4:**  
The Cleaning Assembly...

The Cleaning Blade is held on by two screws which, oddly enough, there are no indexing pins... so the blade could be reinstalled in a variety of positions. I found that unnerving, so I think it wise to mark the position of the blade before removing the screws.

With the blade off, you can empty the toner reclaim compartment, dumping it over a disposal container (wear a mask, this will be messy). A vacuum with a good toner rated filter should be able to get a majority of the toner out of there. When you install a new blade, make sure it lines up with the marks you made before you removed the screws so that you can count on the blade to clean the drum evenly from end to end.

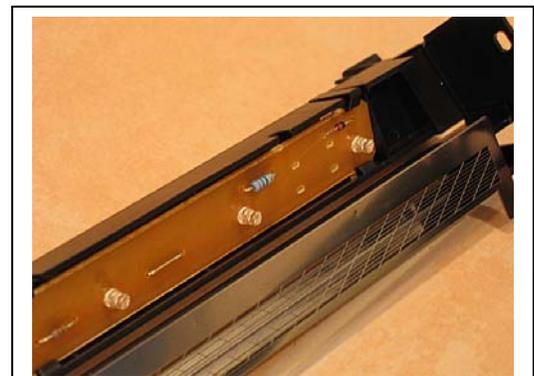
**Photo 5:**  
The reset Fuse...

Next you'll want to turn your attention to the Charge Corona / Discharge Lamp Assembly. The Discharge Lamp Board is clipped in place and is easily removed... you will find a series of LED's as well as a couple of resistors and, yes a drum reset fuse. Here's where the soldering comes in... Once you've replaced the fuse, clean up the Charge Corona thoroughly grid and all and then reassemble the assembly.

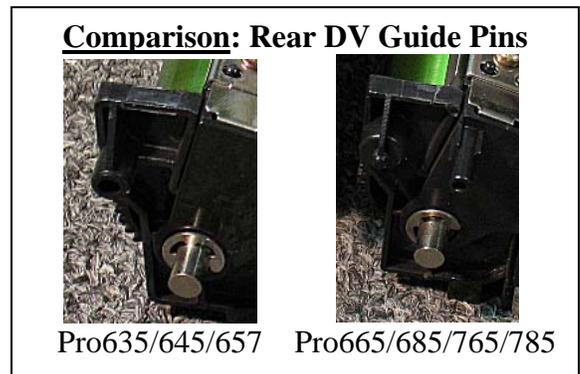
Now perhaps you're wondering as, I was, what is the difference between the two styles of cartridges? The drums and blades and the fuse are identical... the difference lies in the way the cartridge interfaces with its respective Developer Unit in the machine. The pins front and rear near the drum are different in shape with the Pro645 version being a little smaller in diameter and the Pro665 also has an extra pin sticking off the rear end. Take a peek at the photo comparison of the rear pins...
